### CERTIFICATE OF APPROPRIATENESS #14.10 TYPE II

*Property*  
Si View Park  
400 SE Orchard Drive  
North Bend, Washington

*Scope of Work*  
Reconfigure interior spaces and replace certain interior elements in the Fieldhouse

RE: Evaluation report for the existing fir flooring located at Si View Metro Parks District in North Bend, Washington.

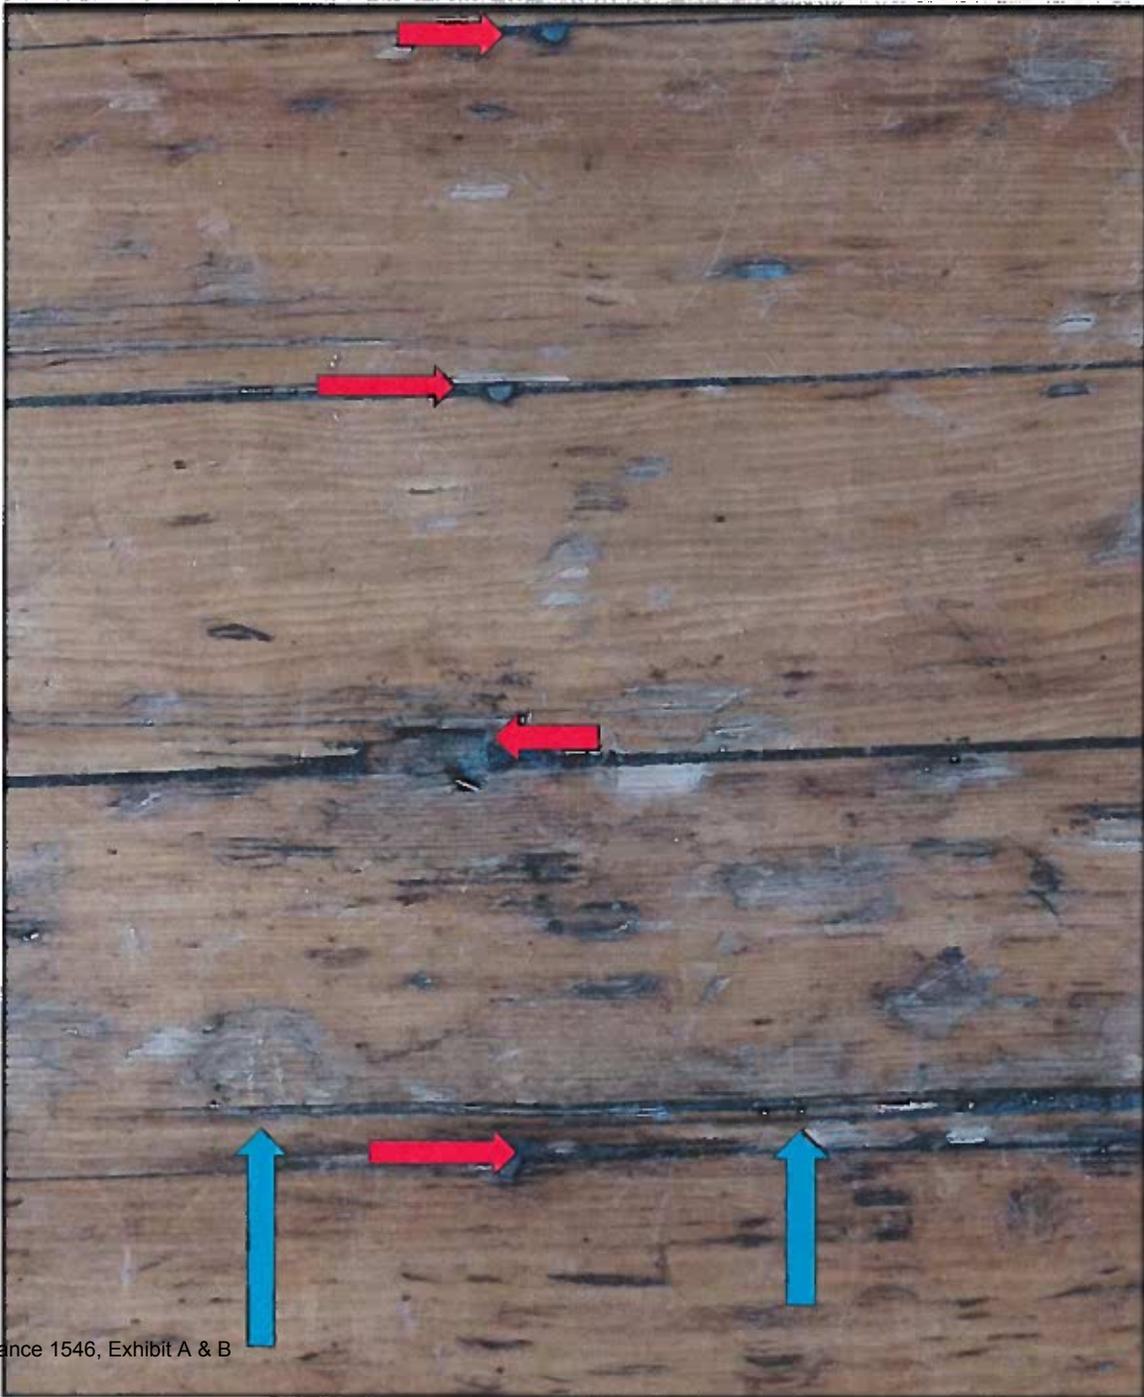
**Red arrow** – Exposed nail head.

**Blue arrow** – Splitting at the top groove section of a tongue and groove joint. The floor boards have gone past their tolerance for sanding and are now too thin which produces splitting at their thinnest areas.

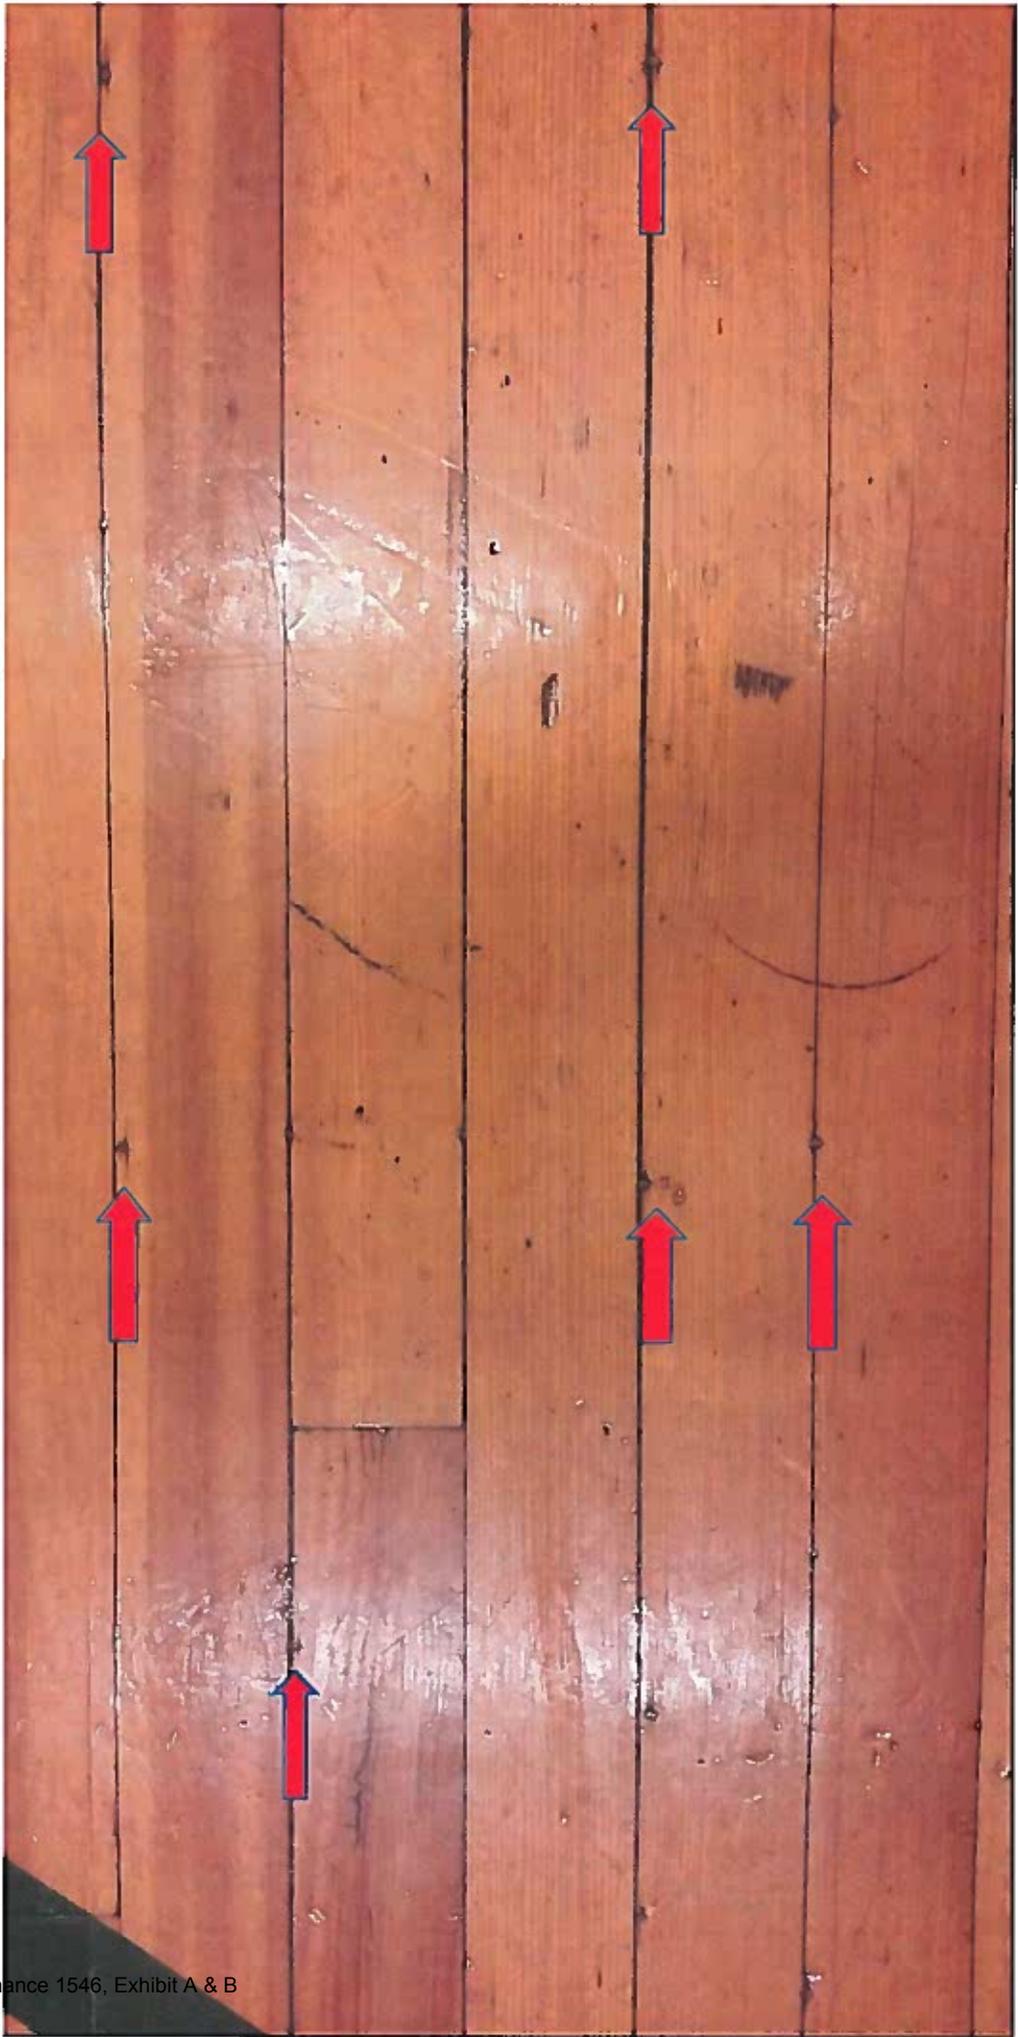
**GYM FLOOR. Red arrows show exposed nails, indicating thin worn boards.**

5. Our recommendation would be to remove the fir flooring in the gym and then replace it with #1 Maple and use a gloss finish.
6. In areas other than the gym, a hardwood should be used as well, select white oak would look best and it is the most durable. We would recommend using an oil based finish using linseed oil instead of a soy oil commonly used, this may help match the color/feel of the fir that is in place and while also providing durability.

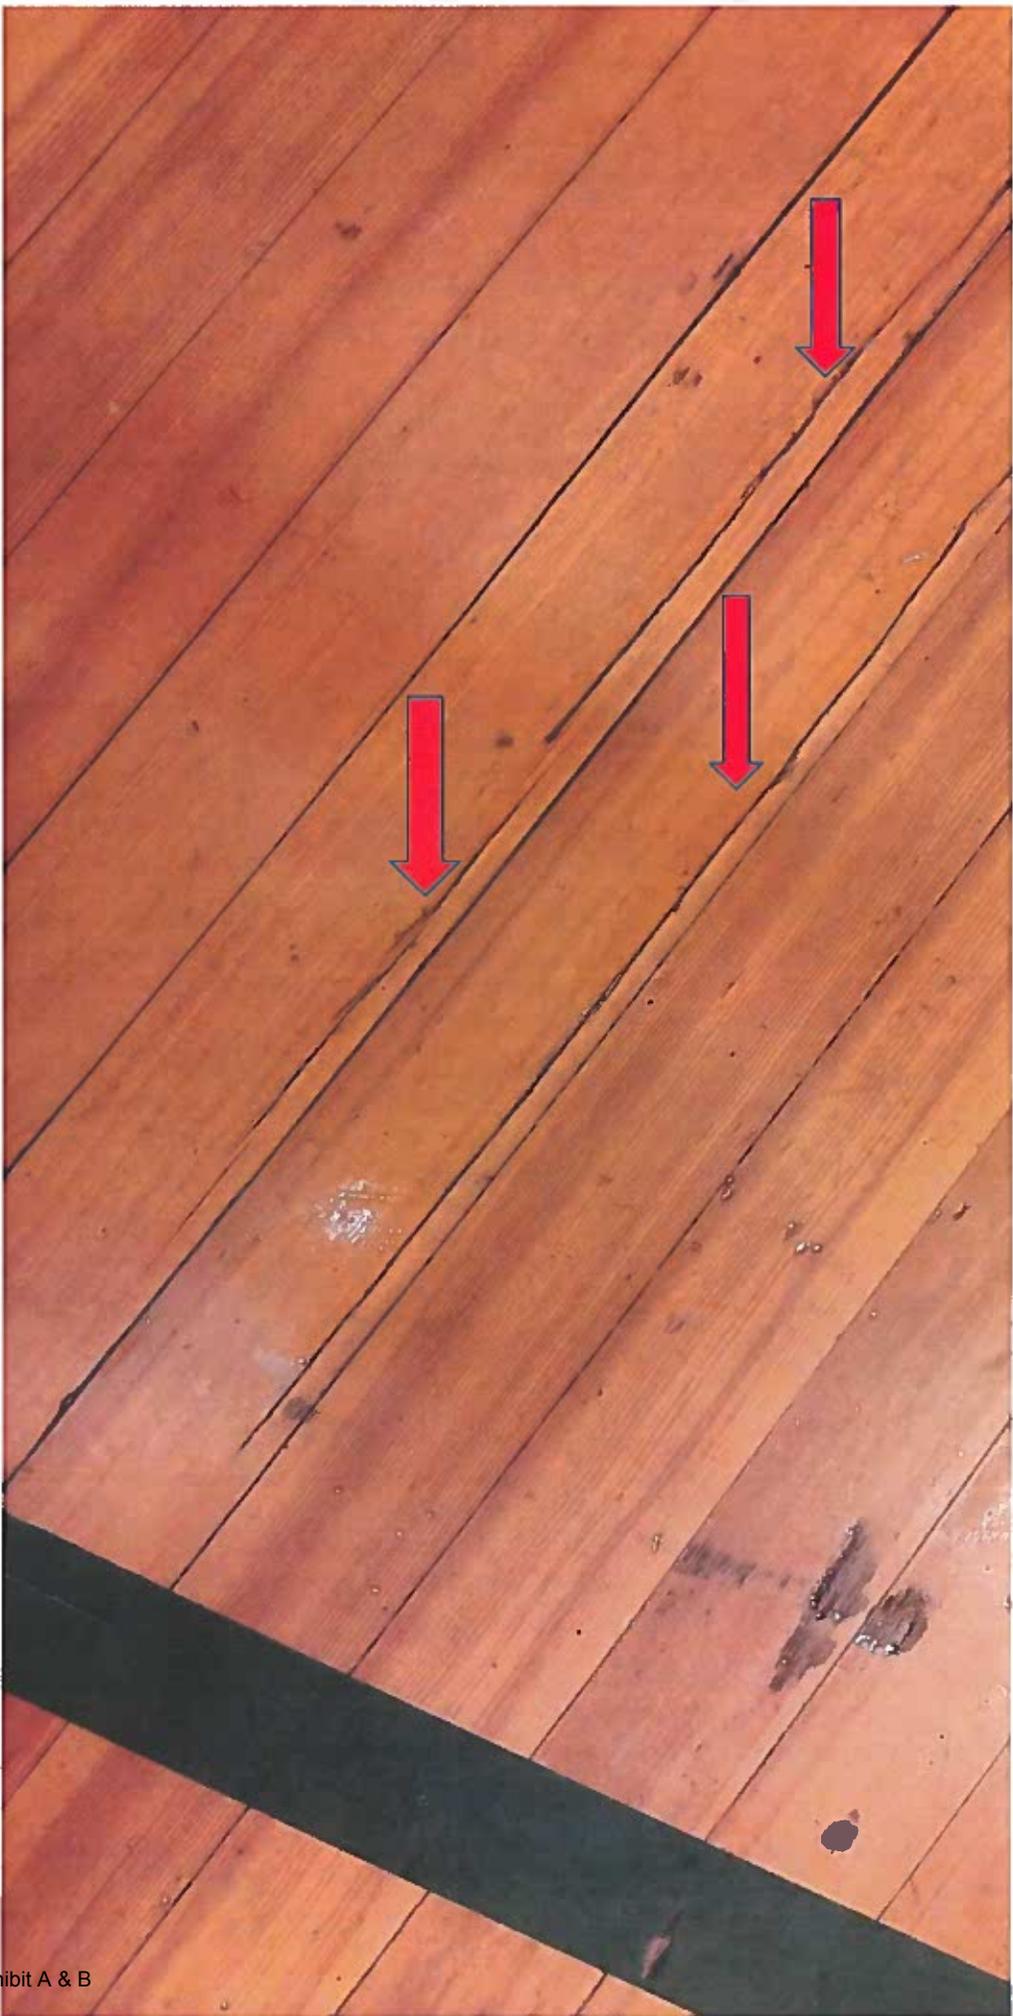
**GYM FLOOR. Red arrows show splitting of wood near the board nails.**

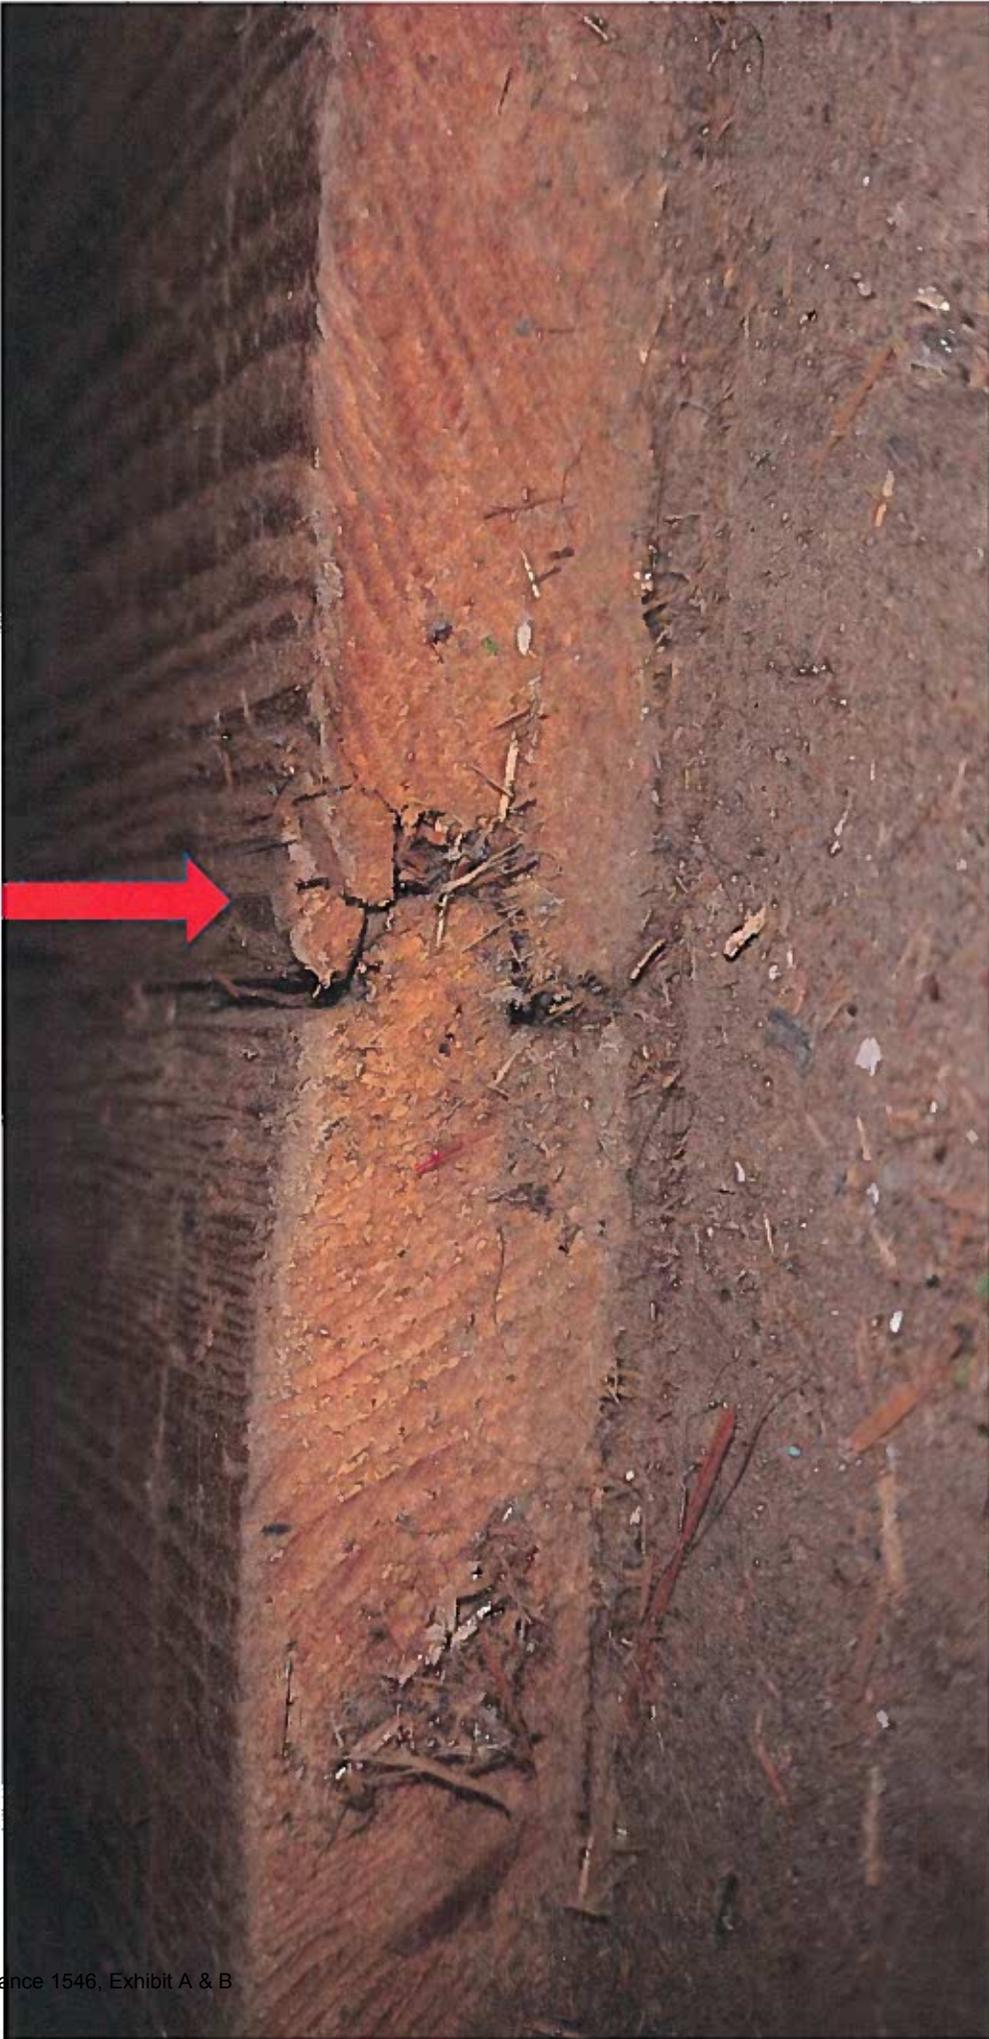
**CROSS SECTION OF FLOOR BOARD. Arrow shows the area where splitting occurs.**

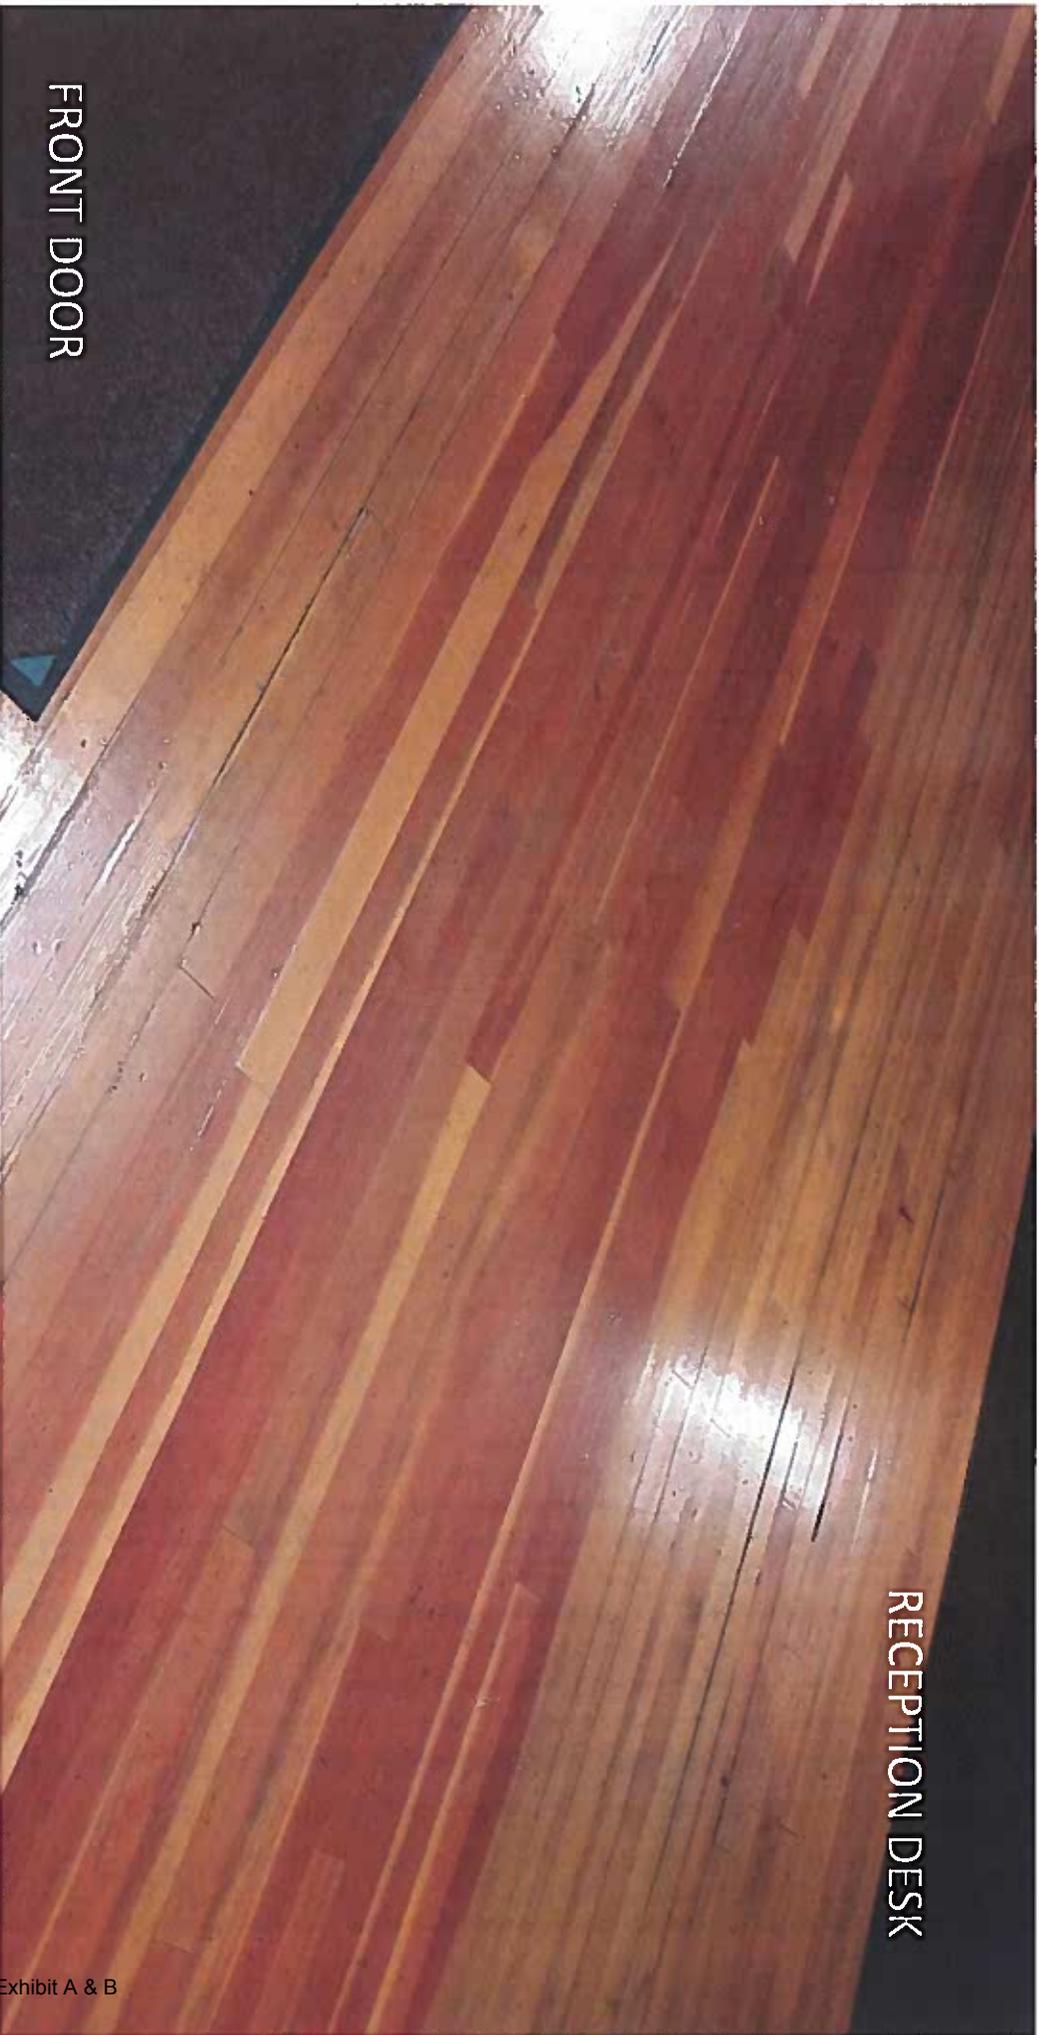
**Front Entrance Area – multiple past repairs are visible.**

7. Reviewing the remodel plans, it was mentioned that wood flooring was planned for the main entrance area of the building. It is our recommendation, from our many years of experience, that wood in this location is not suitable. We strongly advise against using any kind of wood flooring in a heavily used and often wet location. There was mention of an alternate plan of using slate which would be the proper flooring under those conditions.

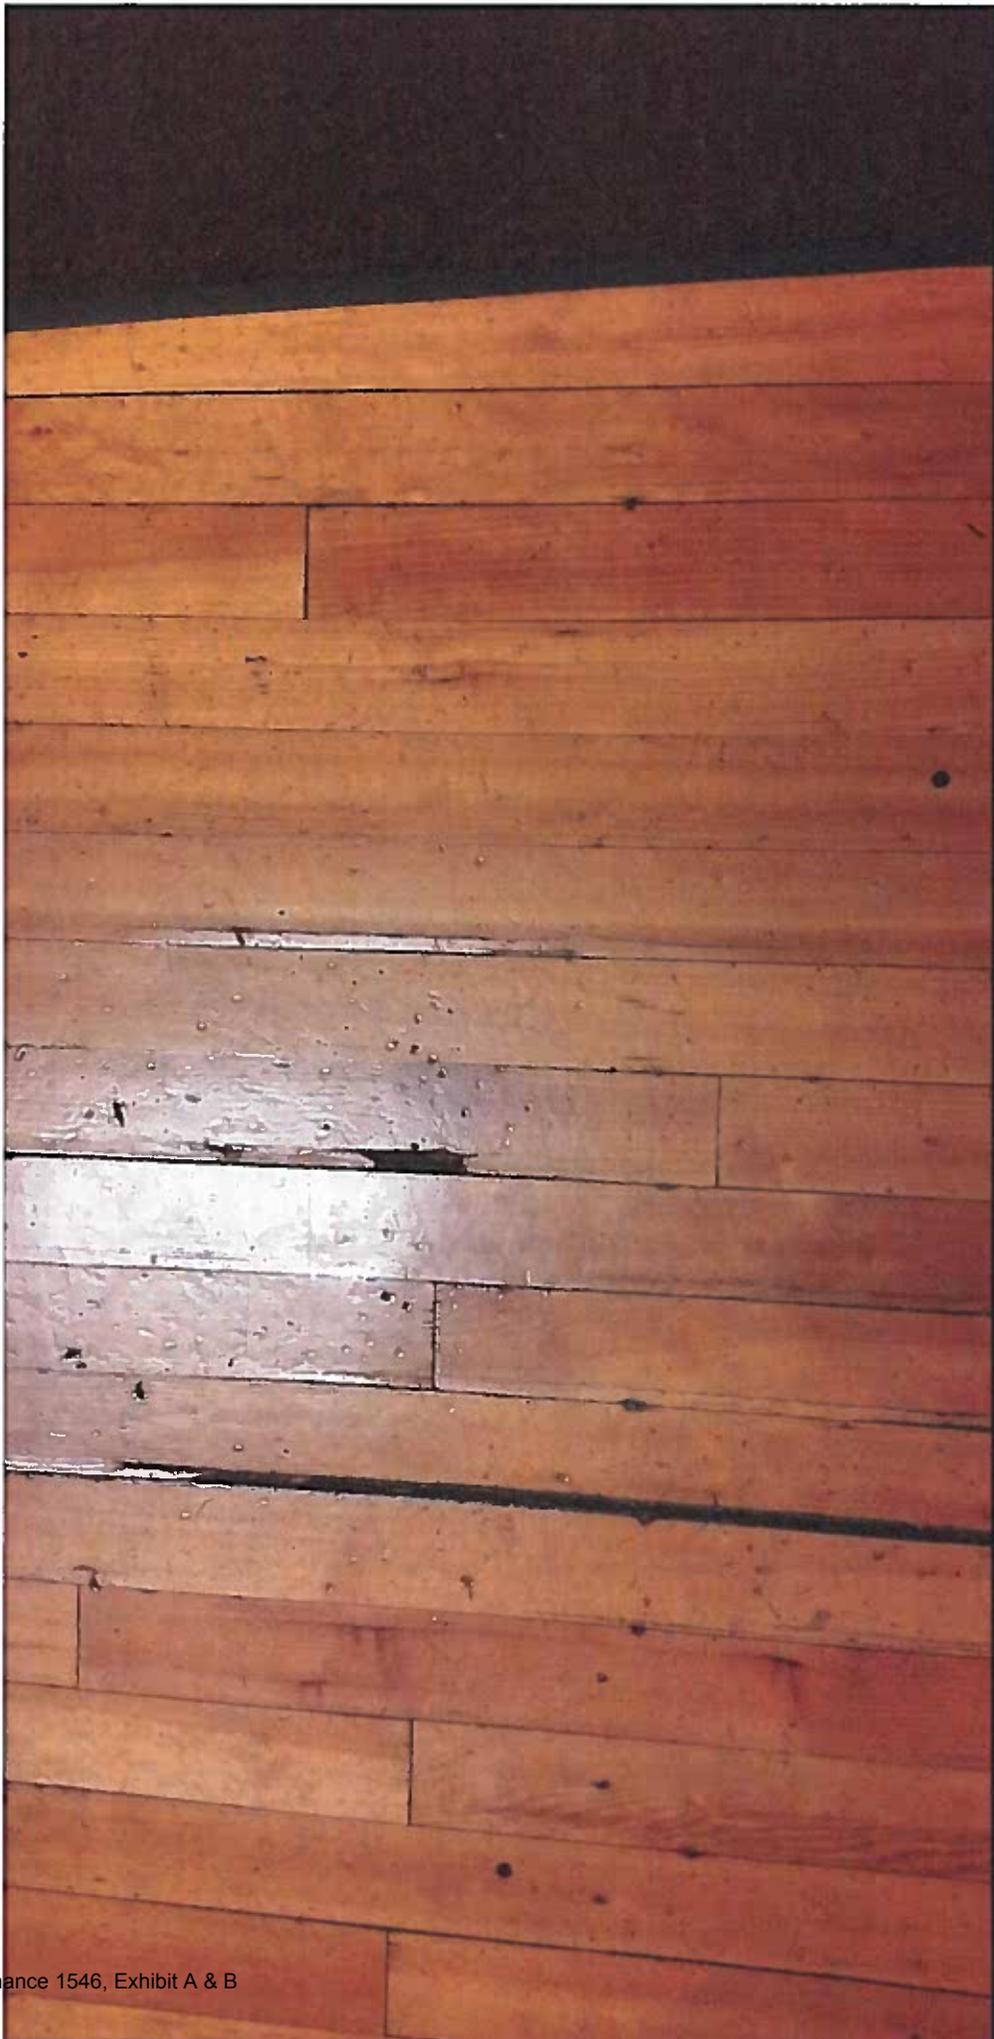
**FRONT ENTRANCE AREA**

**ENTRANCE RECEPTION AREA. Closer view of exposed nails, and spitting on the fir boards, even on repaired areas.**

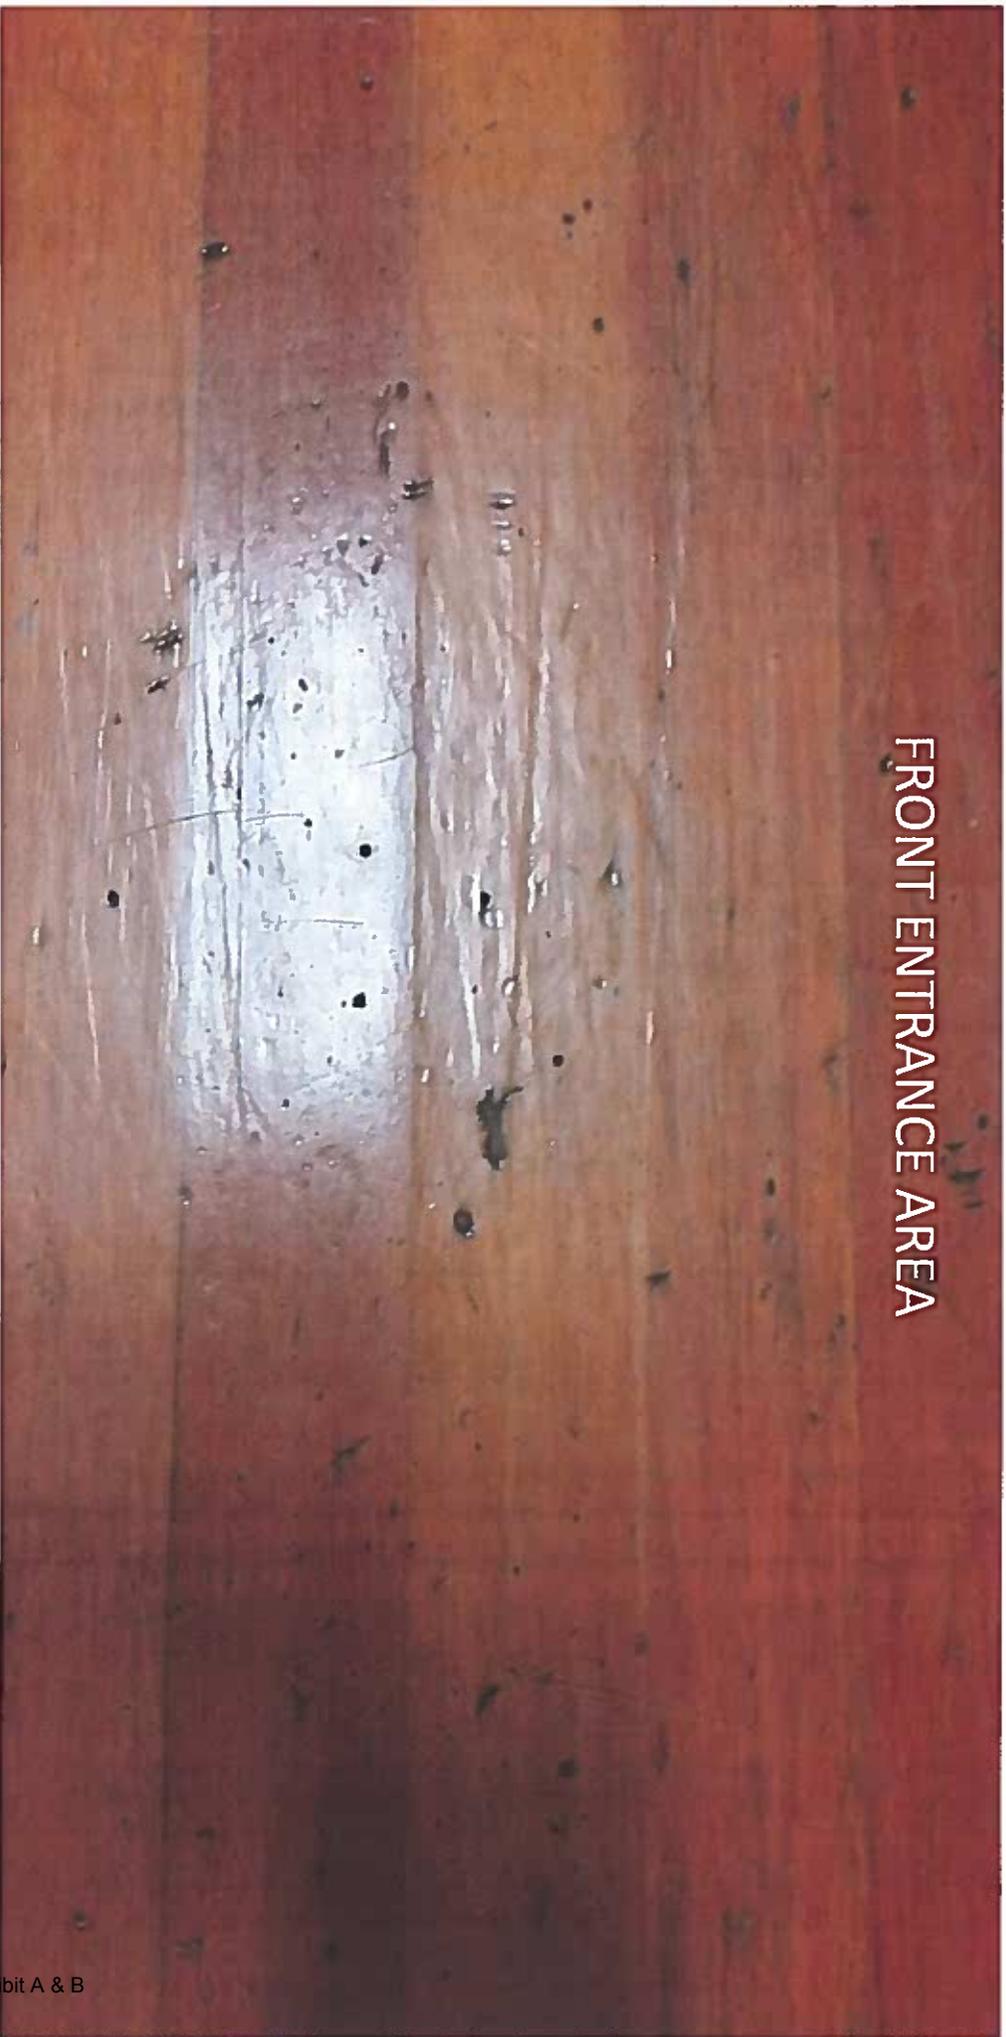
FRONT ENTRANCE

**CLOSE-UP OF RECENT REPAIR. Just beyond the rug, abrasions and pitting from gravel, debris, moisture and heavy foot traffic are visible.**

OLDER REPAIR

NEWER REPAIR

My recommendation for the gym and other rooms would be going with Maple flooring. Maple is a hard wood that would hold up better over time. The only area that I would not recommend Maple would be in the lobby area. With all of the traffic that you will have coming in through the front doors, I think something like a stone or tile would be better served to take the abuse of dirt and water being tracked in.

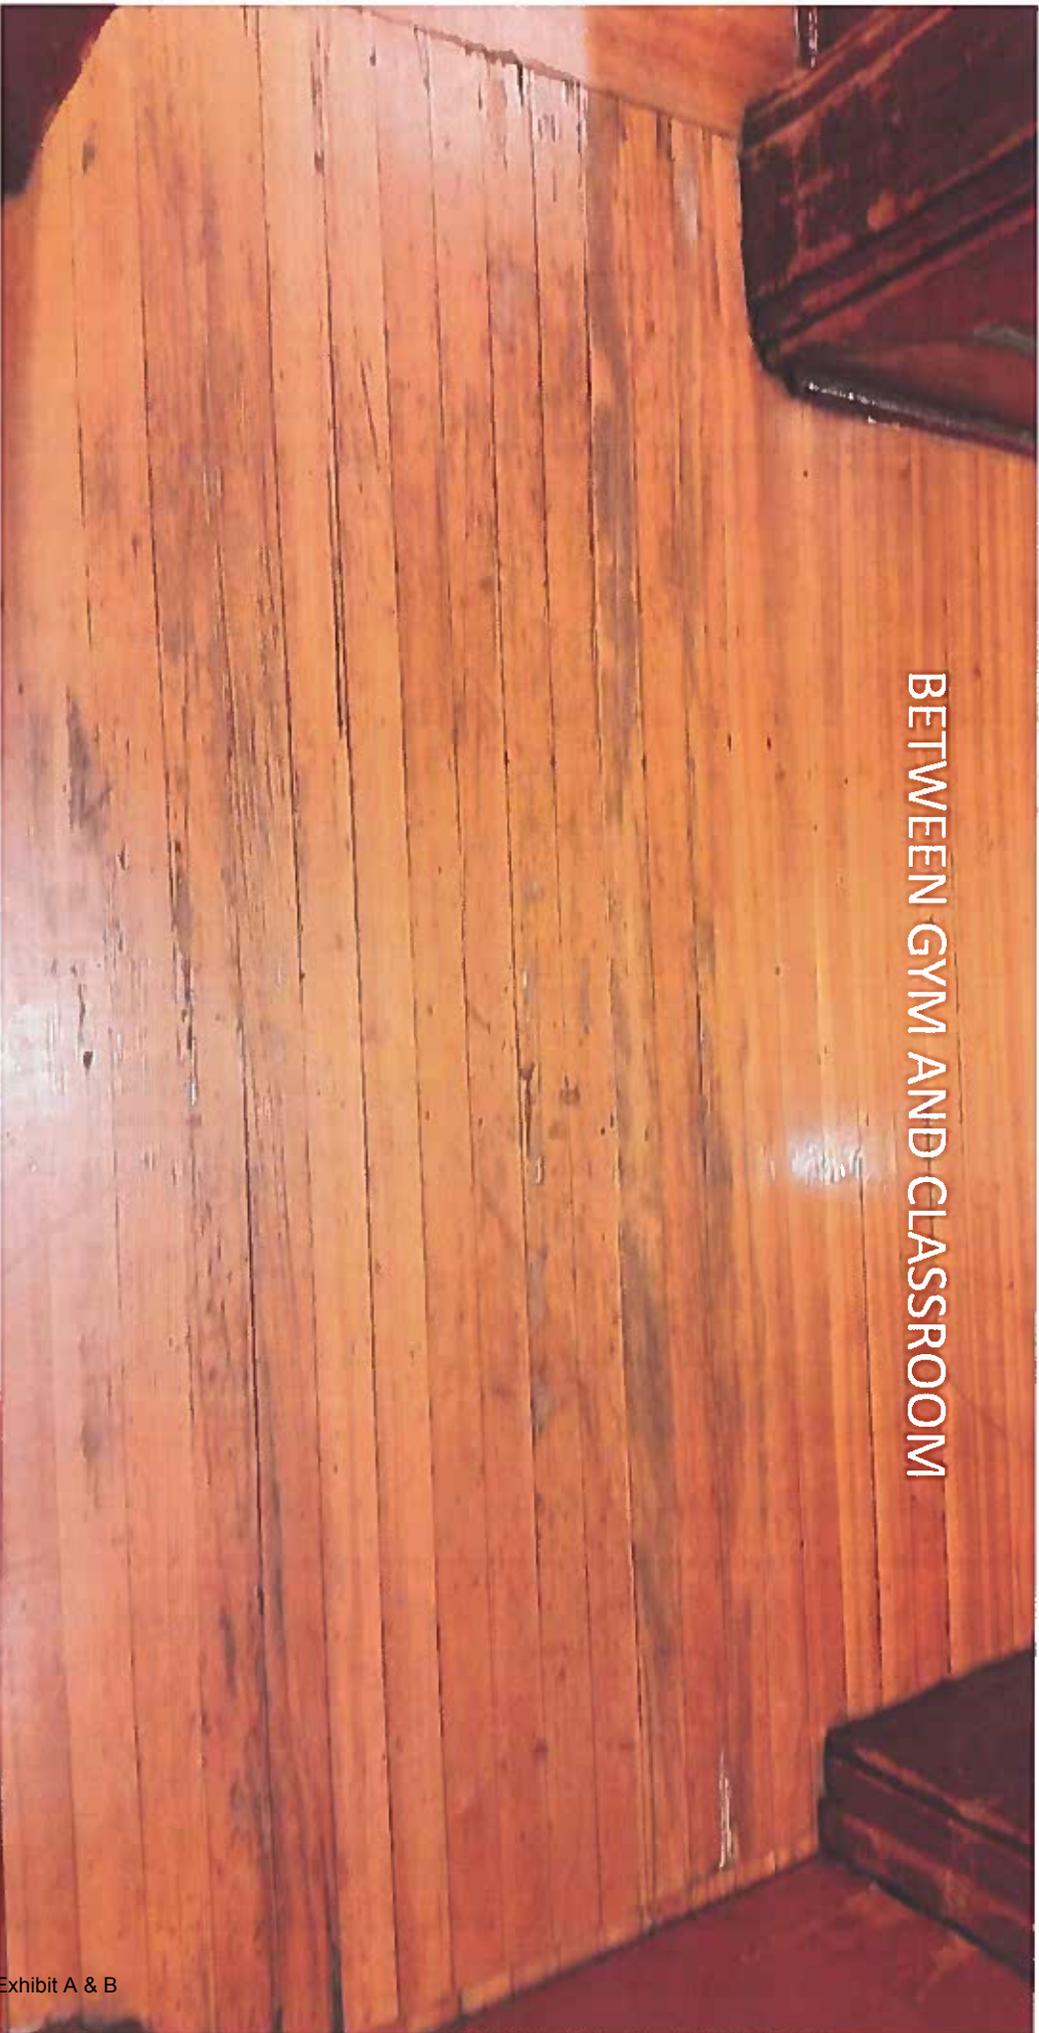
BETWEEN GYM AND CLASSROOM

HALLWAY BETWEEN ROOMS. Heavy foot traffic shows wear pattern.
